Subject: **April 2012 Compliance Evaluation Inspection**

**CWA COMPLIANCE EVALUATION INSPECTION REPORT
U.S. ENVIRONMENTAL PROTECTION AGENCY, REGION 5**

L'Anse Warden Electric Company
Fuel Aggregation Facility
17696 U.S. Highway 41
L'Anse, Michigan 49946
46.749590, -88.462230

April 26 –April 27, 2012

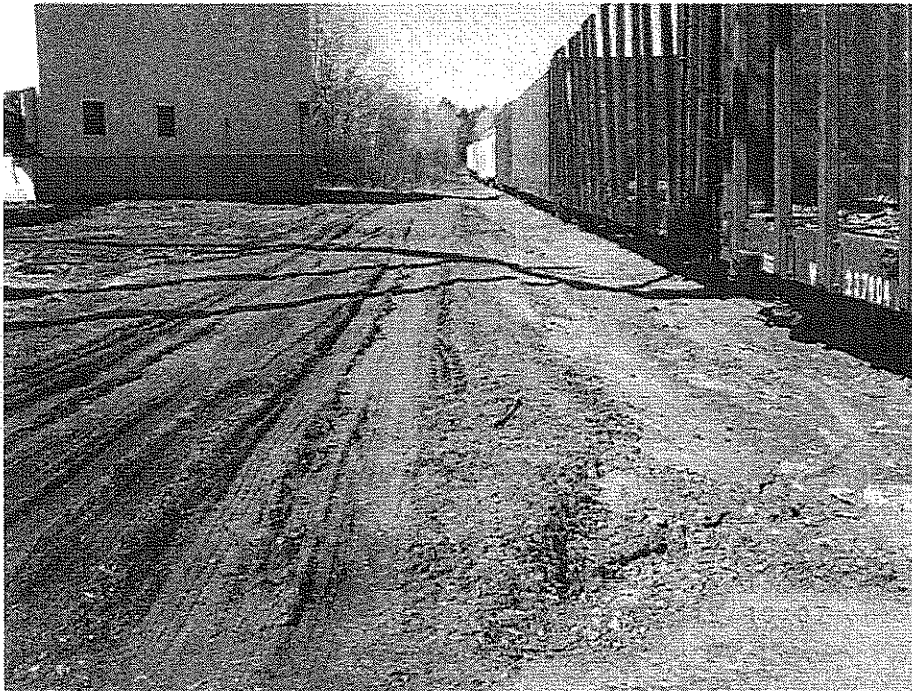
I observed a runoff pathway along the south edge of the railroad tracks that entered the ditch at the northwest corner of the wood room building. A facility representative identified the sources of storm water that contributed to the pathway as the runoff from the central dirt area in the FAF and from a Verso wood storage area culvert (Photo IMGP9092). I observed that the re-chipping pile was upslope of the runoff pathway. The pathway was well defined until it entered the woods at which time it became vegetated (Photo IMGP9094, IMGP9095, IMGP9096 and IMGP9093). The ditch connected with the stream that runs along the west side of the FAF. There were no structural controls around the pathway at the time of the inspection.

Photo IMGP9093: Runoff pathway along the south side of the railroad tracks leading to the ditch at the northwest corner of the wood room building.
Direction: Facing west.
